# OHIO SCHOOL BUS STANDARDS AND INSPECTION MANUAL

## OHIO STATE HIGHWAY PATROL LICENSING AND COMMERCIAL STANDARDS

Revision Date: November 2023

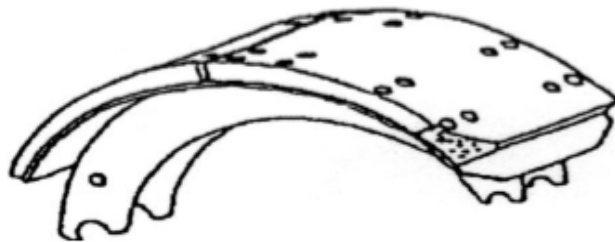
Out-of-Service  
Portion of lining missing that exposes a fastening device.

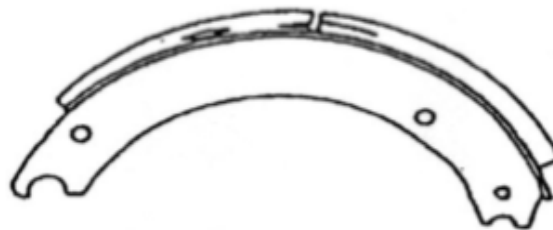
Out-of-Service  
Cracks or voids that exceed 1/16" in width.  
Cracks that exceed 1-1/2" in length.
