# OHIO SCHOOL BUS STANDARDS AND INSPECTION MANUAL

2022

## OHIO STATE HIGHWAY PATROL LICENSING AND COMMERCIAL STANDARDS

Revision Date: March 2022

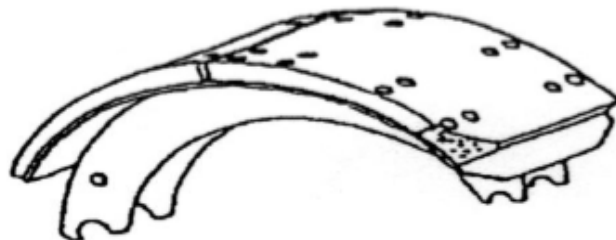
Out-of-Service  
Portion of lining missing that exposes a fastening device.

- ANY defective brake on the vehicle. A defective brake includes any brake that meets one of the following:
  - General:
    - Absence of effective braking action upon application of the service brakes (Such as brake linings failing to move or contacting braking surface upon application).
    - Missing or broken mechanical components including: shoes; linings; pads; springs; anchor pins; cam rollers; pushrods, and air chamber mounting bolts.
    - Loose brake components including air chambers and camshaft support brackets.
  - Brake linings or pads which are cracked, missing or loose; oil seepage into or out of the brake lining/drum interface area; any lining below manufacturer's recommended thickness.

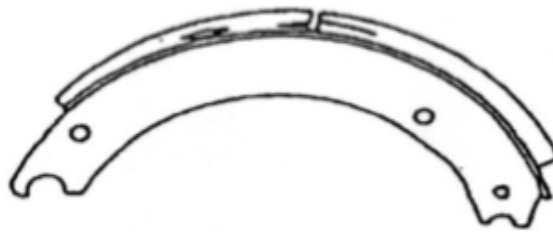
Out-of-Service  
Cracks or voids that exceed 1/16" in width.  
Cracks that exceed 1-1/2" in length.
